# OSCE Radiological Fact Finding Mission Metallurgical Plant, JSCC "Moldova Steel Works" Rybnitsa

Transdniestrian Region, Moldova

1 to 4 December 2003

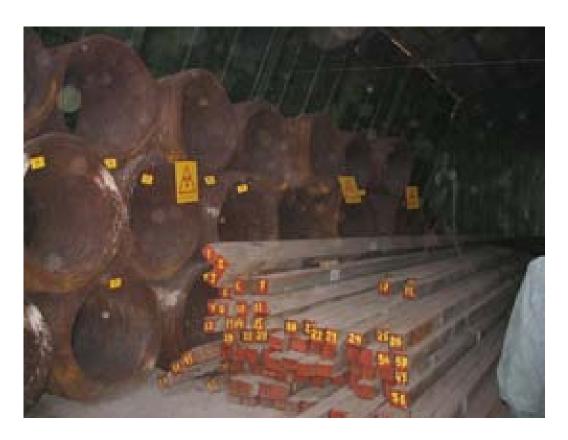
Figure 1: Contaminated steel products from the source-melting (<sup>60</sup>Co) event, in store

No measurable radiation from <sup>60</sup>Co was detected in the surroundings of the storage building where the contaminated end-products were stored. Inside the store dose rates were in the range of 0.2 microSv/h near the entrance.

- No contamination from <sup>60</sup>Co was detected on the site and in the samples; the plant staff confirmed that according to their measurements <sup>60</sup>Co appeared only in the steel product confined in a storage building;

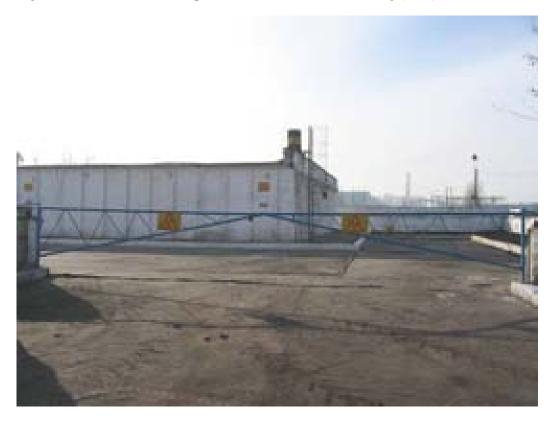
Figure 2: Storage facility for contaminated dust resulting from the source-melting event in 2002

Surveys were also done close to the concrete fence at the perimeter of the temporary waste storage facility where contaminated dust from the first <sup>137</sup>Cs source melting event during August 2000 was stored, Figures 2,3 and 4.

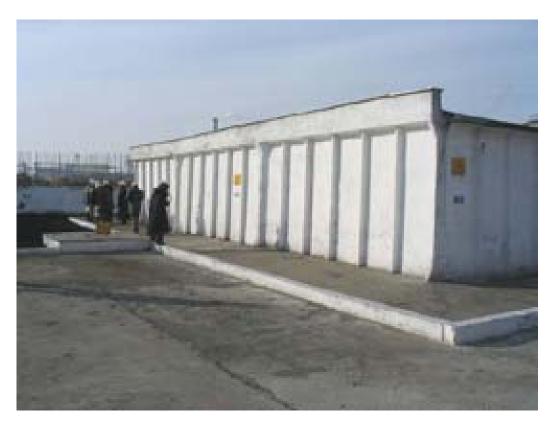
Figure 3: Side view of the contaminated dust storage facility

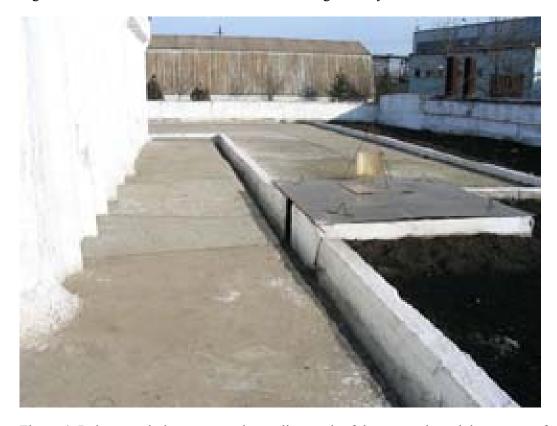
Figure 4: Rainwater drain system and sampling vault of the contaminated dust storage facility

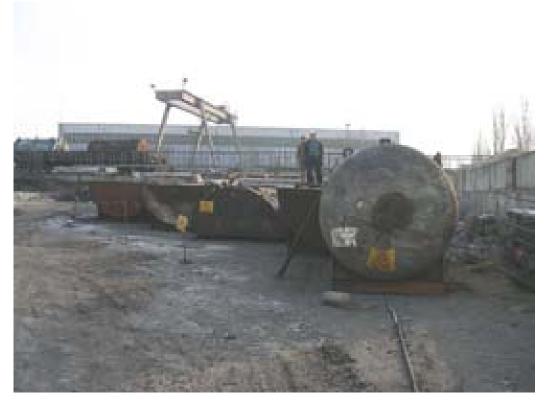
Figure 5: Tanks containing contaminated dust from the source-melting event (137Cs) in 2003

Samples were taken from three tanks for dust storage Figures 5, 6 and 7, at the dust piles yard Figures 8 and 9, on the internal roads at the crossing identified between buildings number 64 and 65 as indicated in the Plant layout, at the Plant vehicles access gate 58 and in the cabin of one of the trucks used to transport dust from the bunkers to the dust yard Figure 10. From Scoria store small pebbles were taken for analysis.

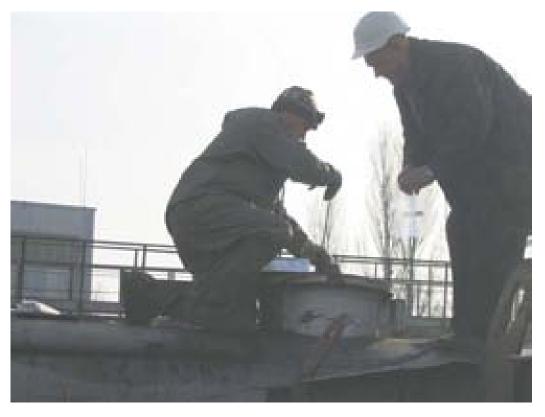
Figure 6: Sampling of the contaminated dust from the source-melting event (137Cs) in 2003

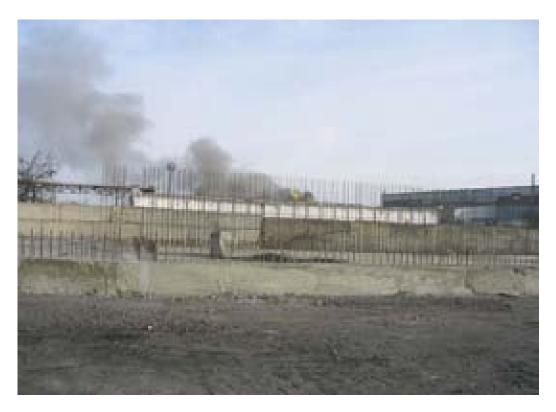
Figure 7: Construction of the new storage facility for contaminated dust from the source-melting event ( $^{137}$ Cs) in 2003

- The waste storage facility constructed after the first and second incidents as well as the
  work carried out to clean up the site and build a new store for the waste resulting from
  the latest melting event was appropriate;

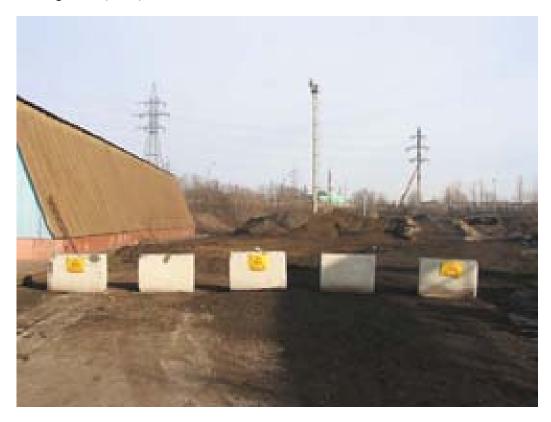
Figure 8: Entrance of the open-air dust storage site and the storage building (left) for contaminated steel product

The measured dose rate values show levels in the range of background except at the dust piles in the open yard and close to the containers with contaminated dust where dose rates were up to several times higher than background.

- No exposure hazard to operational personnel exists at the operational plant installations
- Because of some residual contamination at the open yard, access should be restricted
  to authorized persons. It is recommended that remedial actions to reduce
  contamination be carried out.

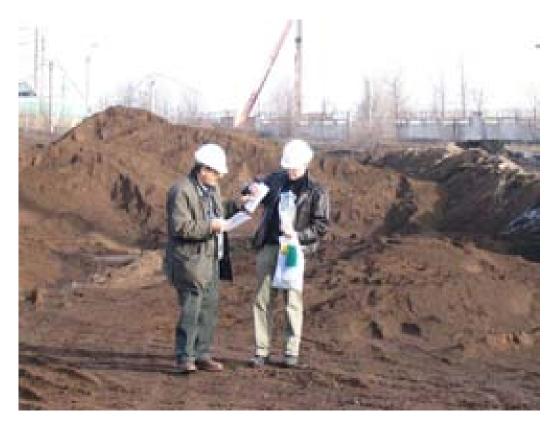
Figure 9: Sampling of dust at the open-air storage site

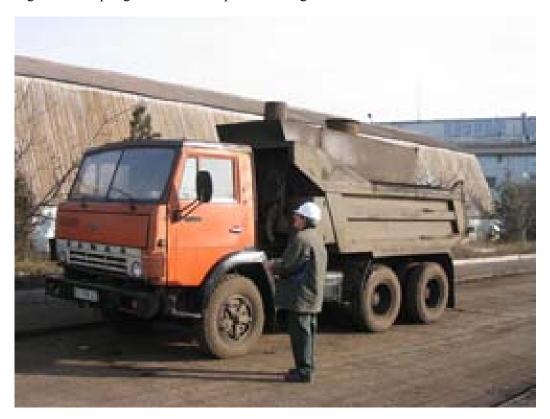
Figure 10: Testing the contamination of a truck which was used for transporting contaminated dust

1	S-1	On floor surface at North corner of disposal facility wall	<lod< th=""></lod<>
2	S-2	Same as 1 at the South corner	<lod< td=""></lod<>
3	S-3	Surface end-product piece in storage	<lod< td=""></lod<>
4	S-4	Surface end-product piece in storage	<lod< td=""></lod<>
5	S-5	Surface end-product piece in storage	<lod< td=""></lod<>
6	S-6	Plant access gate	<lod< td=""></lod<>
7	S-T1	Truck cabin, drive wheel and dials panel	<lod< td=""></lod<>
8	S-T2	Truck cabin, pedals	<lod< td=""></lod<>

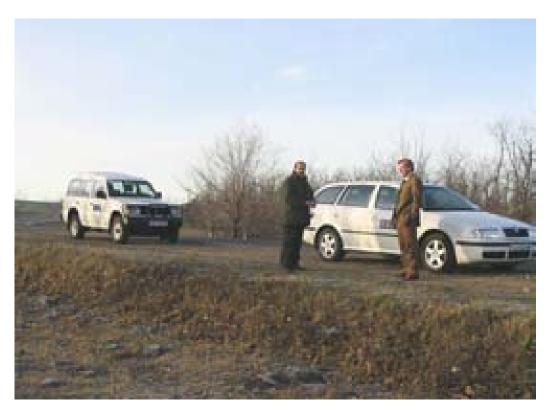
Figure 11: Sampling point on the road from Chisinau to Rybnitsa, about 15 km from the west bank of the Dniester river

Outside the plant soil samples were taken from sidewalks at the plant site and from the field at some 15 km from the Dniester river by the road in direction to Chisinau, Figure 11.

Results from the two samples taken outside the Plant showed no detectable quantity from <sup>137</sup>Cs or <sup>60</sup>Co above background

- Clean up of the dust collectors boxes shall be undertaken to further reduce contamination levels.
- The results from the measures of samples taken at the side walk by the Metallurgical
  plant in Ribnitsia and at some 15 km from the Dniester river in direction to Chisinau
  should be taken cautiously, as test only and not as an environmental analysis. It is
  nevertheless recommended that the environmental monitoring is continued.
